DEPARTMENT OF TRANSPORTATION

Contract #: 04-0120F4Cty: SF/ALA Rte: 80 PM: 13.2/13.9File #: 99.28**WELDING INSPECTION REPORT****Resident Engineer:** Siegenthaler, Peter**Address:** 333 Burma Road**City:** Oakland, CA 94607**Report No:** WIR-018582**Date Inspected:** 11-Dec-2010**Project Name:** SAS Superstructure**OSM Arrival Time:** 700**Prime Contractor:** American Bridge/Fluor Enterprises, a JV**OSM Departure Time:** 1900**Contractor:** Zhenhua Port Machinery Company, Ltd (ZPMC)**Location:** Shanghai, China**CWI Name:** Li Yang and Zhu Zhong Hai**CWI Present:** Yes No**Inspected CWI report:** Yes No N/A**Rod Oven in Use:** Yes No N/A**Electrode to specification:** Yes No N/A**Weld Procedures Followed:** Yes No N/A**Qualified Welders:** Yes No N/A**Verified Joint Fit-up:** Yes No N/A**Approved Drawings:** Yes No N/A**Approved WPS:** Yes No N/A**Delayed / Cancelled:** Yes No N/A**Bridge No:** 34-0006**Component:** OBG Trial Assembly**Summary of Items Observed:**

Orthotropic Box Girder (OBG) at Trial Assembly Areas

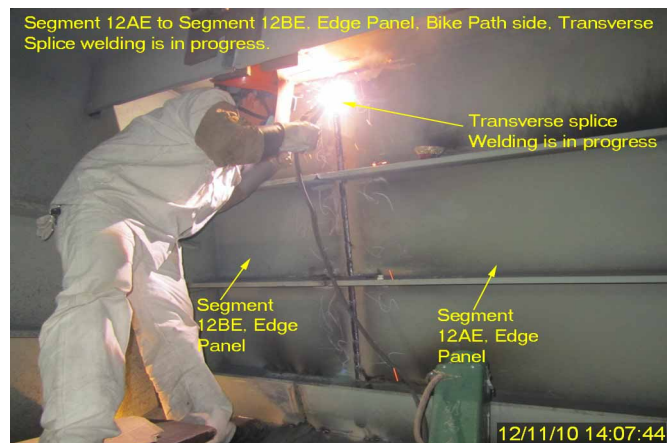
This QA Inspector observed the in-process welding by Shielded Metal Arc Welding (SMAW) process on a Complete Joint Penetration (CJP) groove weld. The Weld joint was designated as CA6502-007. The welder identification was 040320 and was observed welding in the 4G (Overhead) position using approved Welding Procedure Specification WPS-B-P-2214-B-U2-FCM-1. The piece mark was identified as the edge panel splice weld, Bike Path side.
